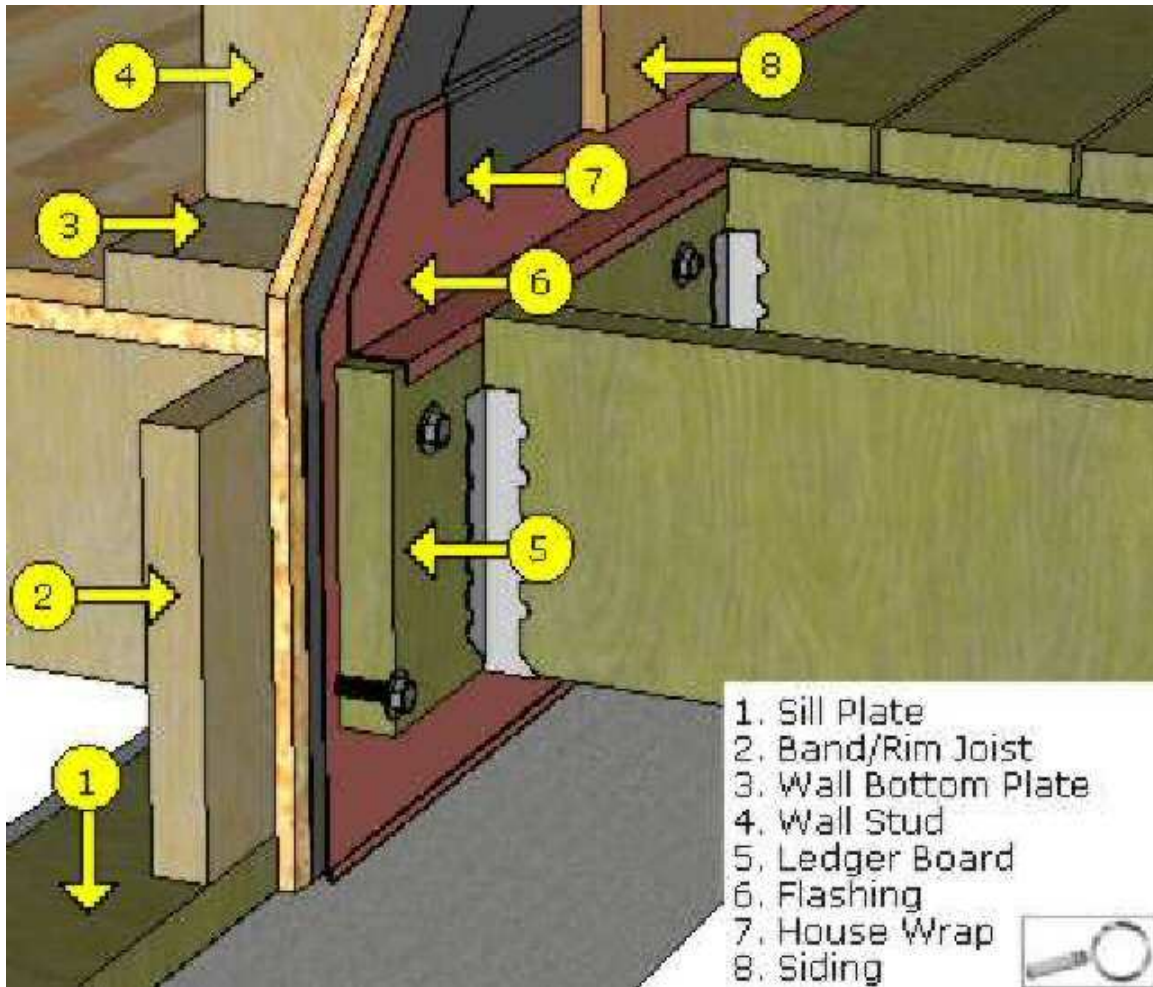
In this photo, note how the House Wrap (item #7) overlaps the flat wall flashing and a second flashing called the Ledger Board (item #5) Cap Flashing (item #6). This method will prevent moisture damage at your house wall sheathing and floor framing areas, however you will rarely ever see a contractor install the Ledger Board Cap Flashing.
