1. Electrical System

1.0 SERVICE ENTRANCE CONDUCTORS

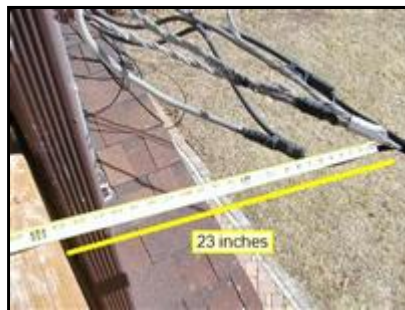
1.0 Picture 1

Service Entrance Conductors are too close to rear balcony railing (less than 3 ft.). Recommend correction by a Licensed or Qualified Electrician. Substantial relocation, alterations or changes may require a permit. Check with local authority having jurisdiction.

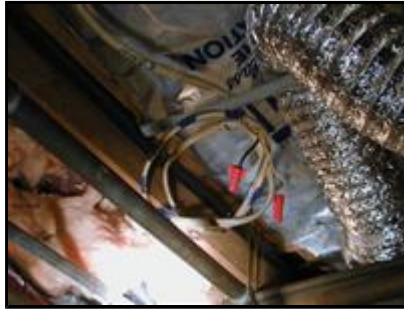
1.3 Picture 1

Active wiring in ceiling of basement utility room is not terminated properly inside a junction box with cover. It

appears this circuit is no longer needed. Recommend correction by a Licensed or Qualified Electrician.
